Manhole Inspection Summary

Manhole # S29MM_003MH

Insp Date: **7/12/07 11:00 AM**

Location Address: **1805 RESERVOIR ST**

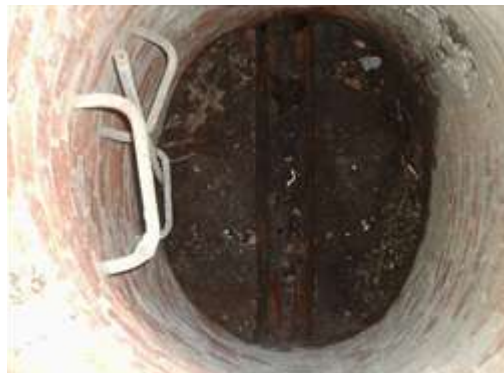
Top View

Evidence of surcharge - Bench debris.
Channel debris.

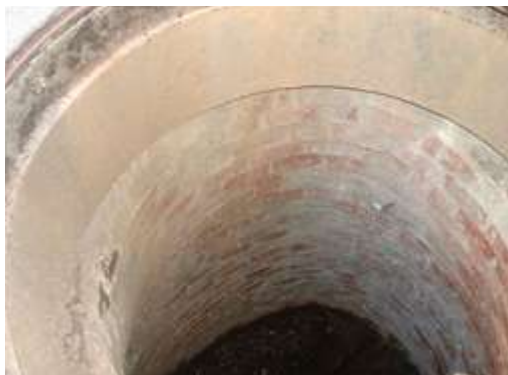
Defect

Frame leaks. Adjustment deterioration
and infiltration. Barrel infiltration - other
side.

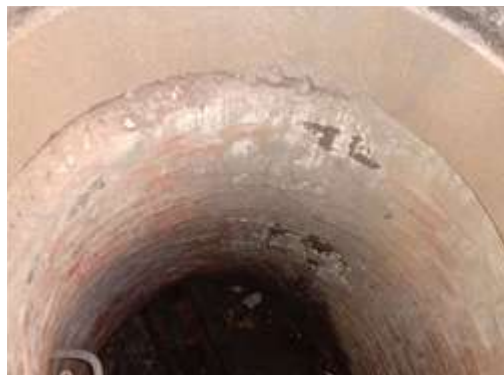
Defect

Frame leaks. Frame offset. Adjustment
deterioration and infiltration. Barrel
infiltration.

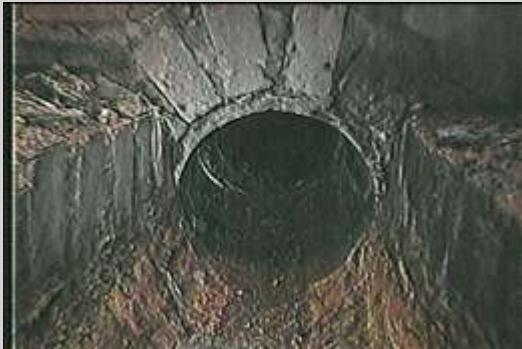
8 in. Circular Gravity Sewer Pipe Out @ 12 O'Clock

Infiltration: **Evidence** Pipe Seal Cond: **Cracked**

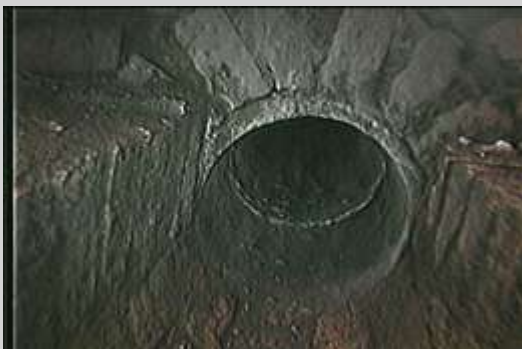
8 in. Circular Gravity Sewer Pipe In @ 6 O'Clock

Infiltration: **Evidence** Pipe Seal Cond: **Unknown**
